CALIFORNIA DIVISION OF MINES AND GEOLOGY
Supplement ^{#2} to Fault Evaluation Report FER-13

March 23, 1978

1. Name of fault: Ventura fault.

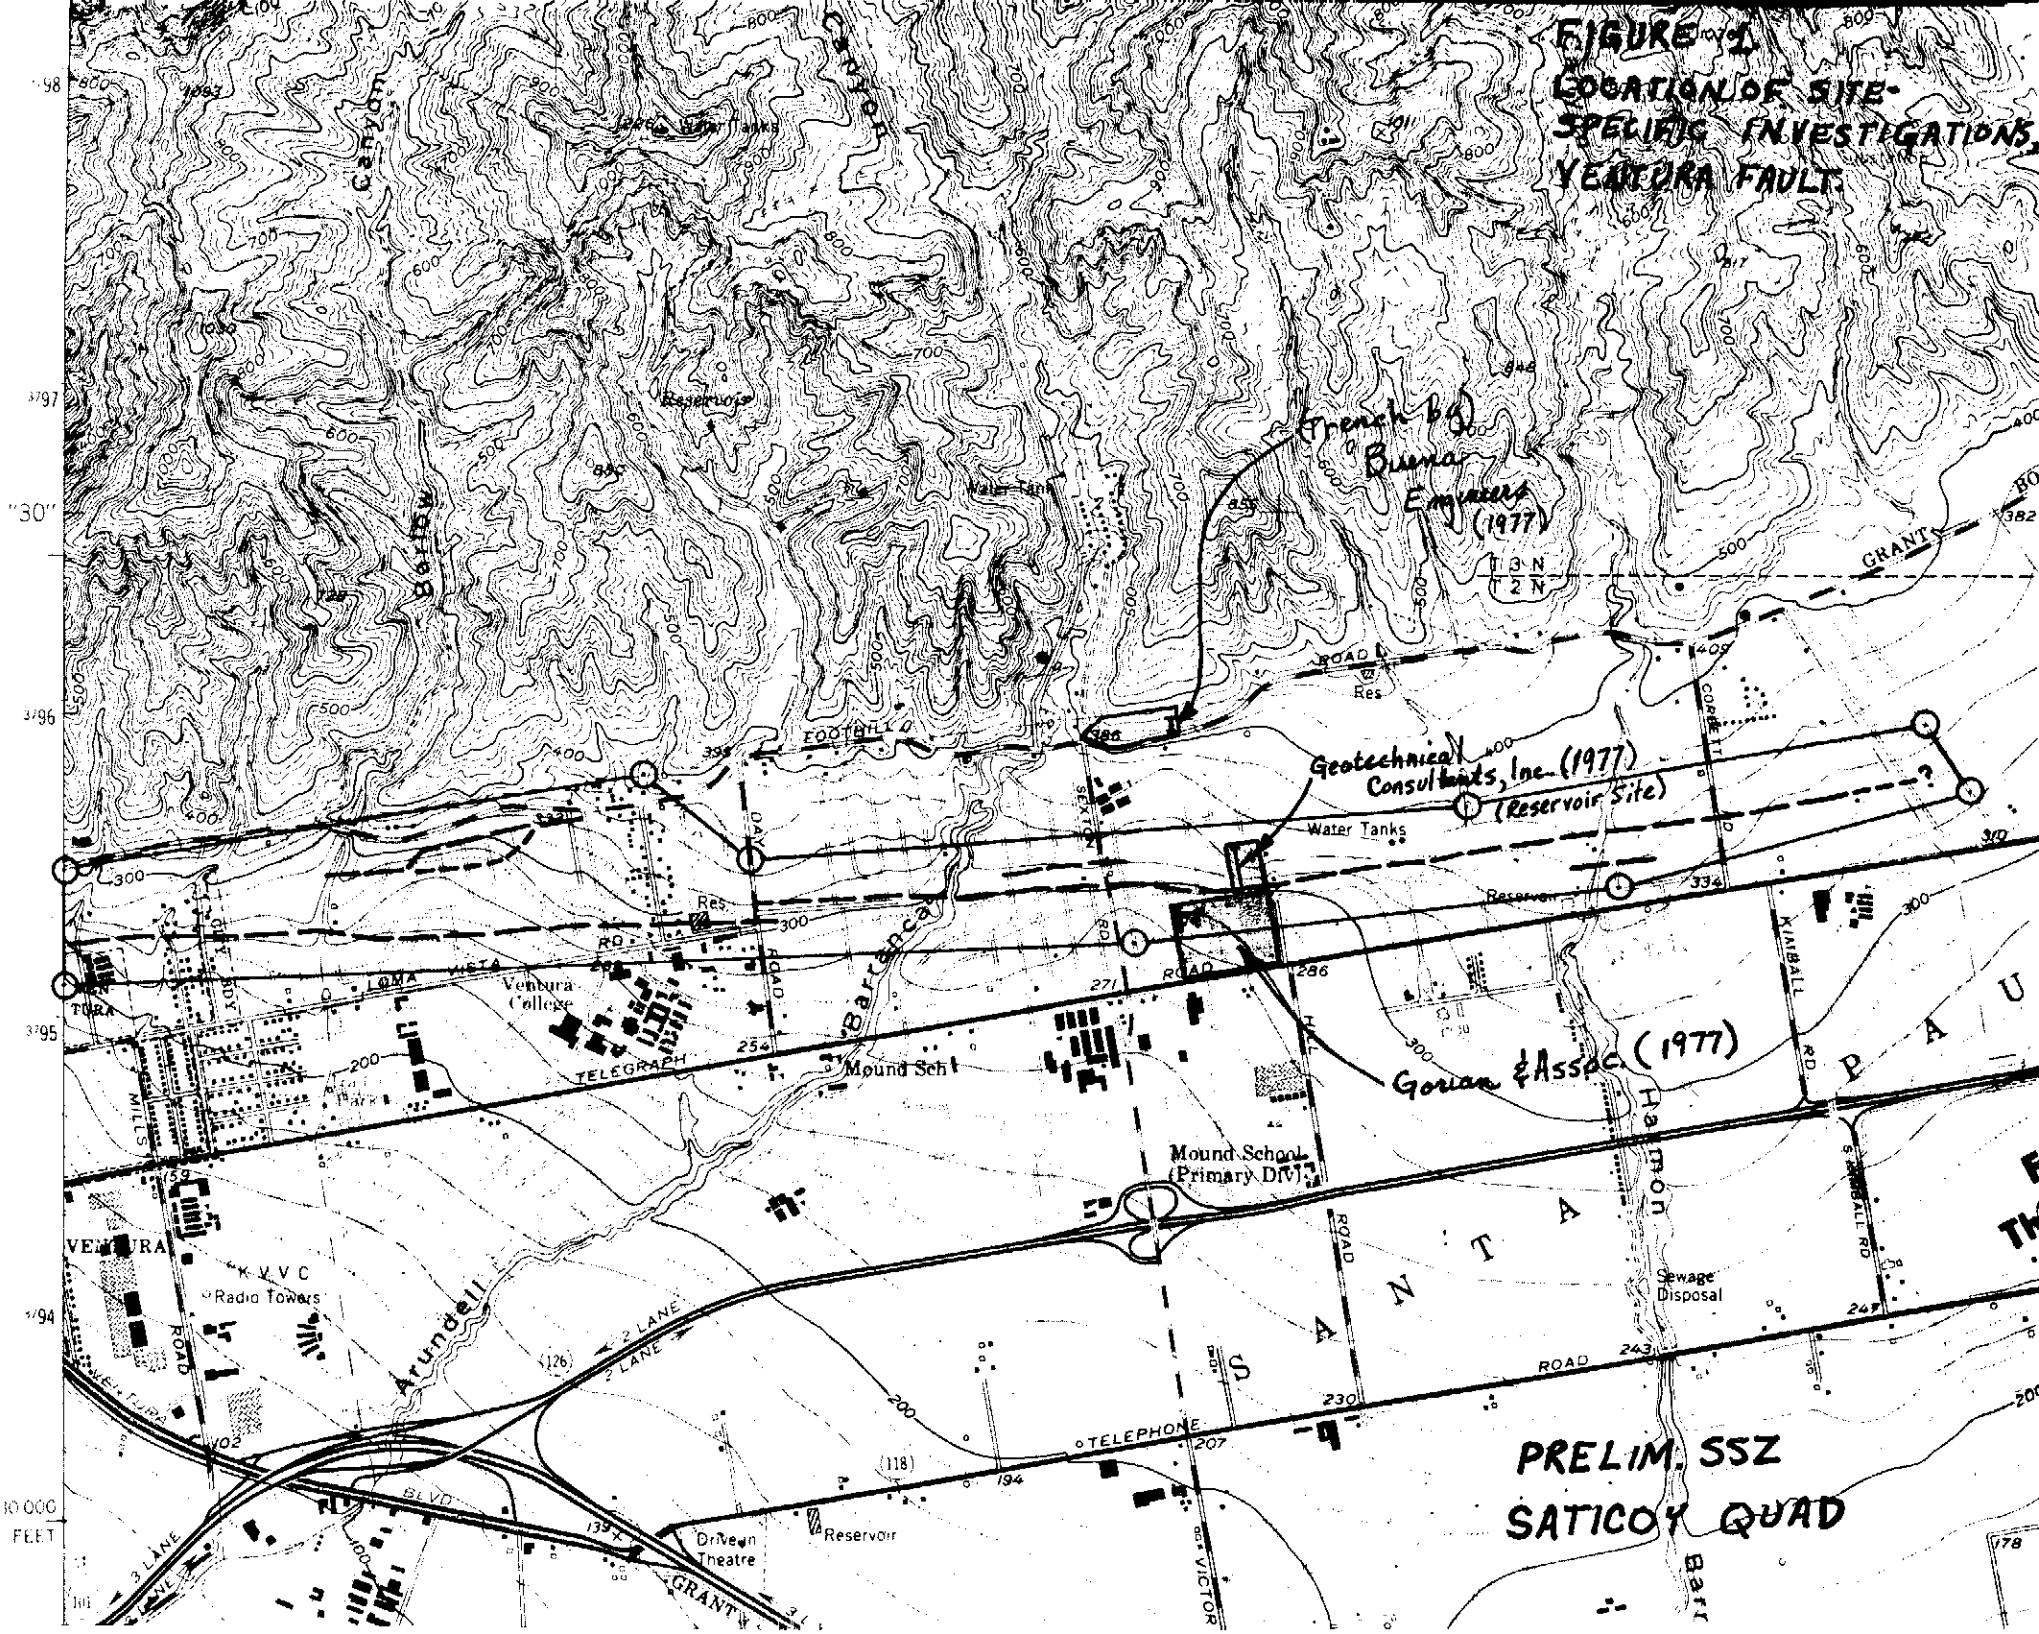
FIGURE 1
LOCATION OF SITE-SPECIFIC INVESTIGATIONS,
YEBERA FAULT.

b. Gorian Associates (1977) report -- this study (figure 1) consists of a 200-foot long, north-south trench excavated about 100 feet south of the base of the topographic escarpment shown by Sarna-Wojcicki, et al. (1976). No evidence of faulting was reported. A sample of wood collected from a depth of 4.3 feet was dated radiometrically as being 450 ± 220 ybp (Smith, 1978).

c. Buena Engineers, Inc. (1977) report -- the site studied lies just north of Foothill Road, a quarter-mile north of the Ventura fault (figure 1). Approximately 200 feet of trenches were excavated to a depth of 5 or 6 feet in a north-south direction. Although the trench logs

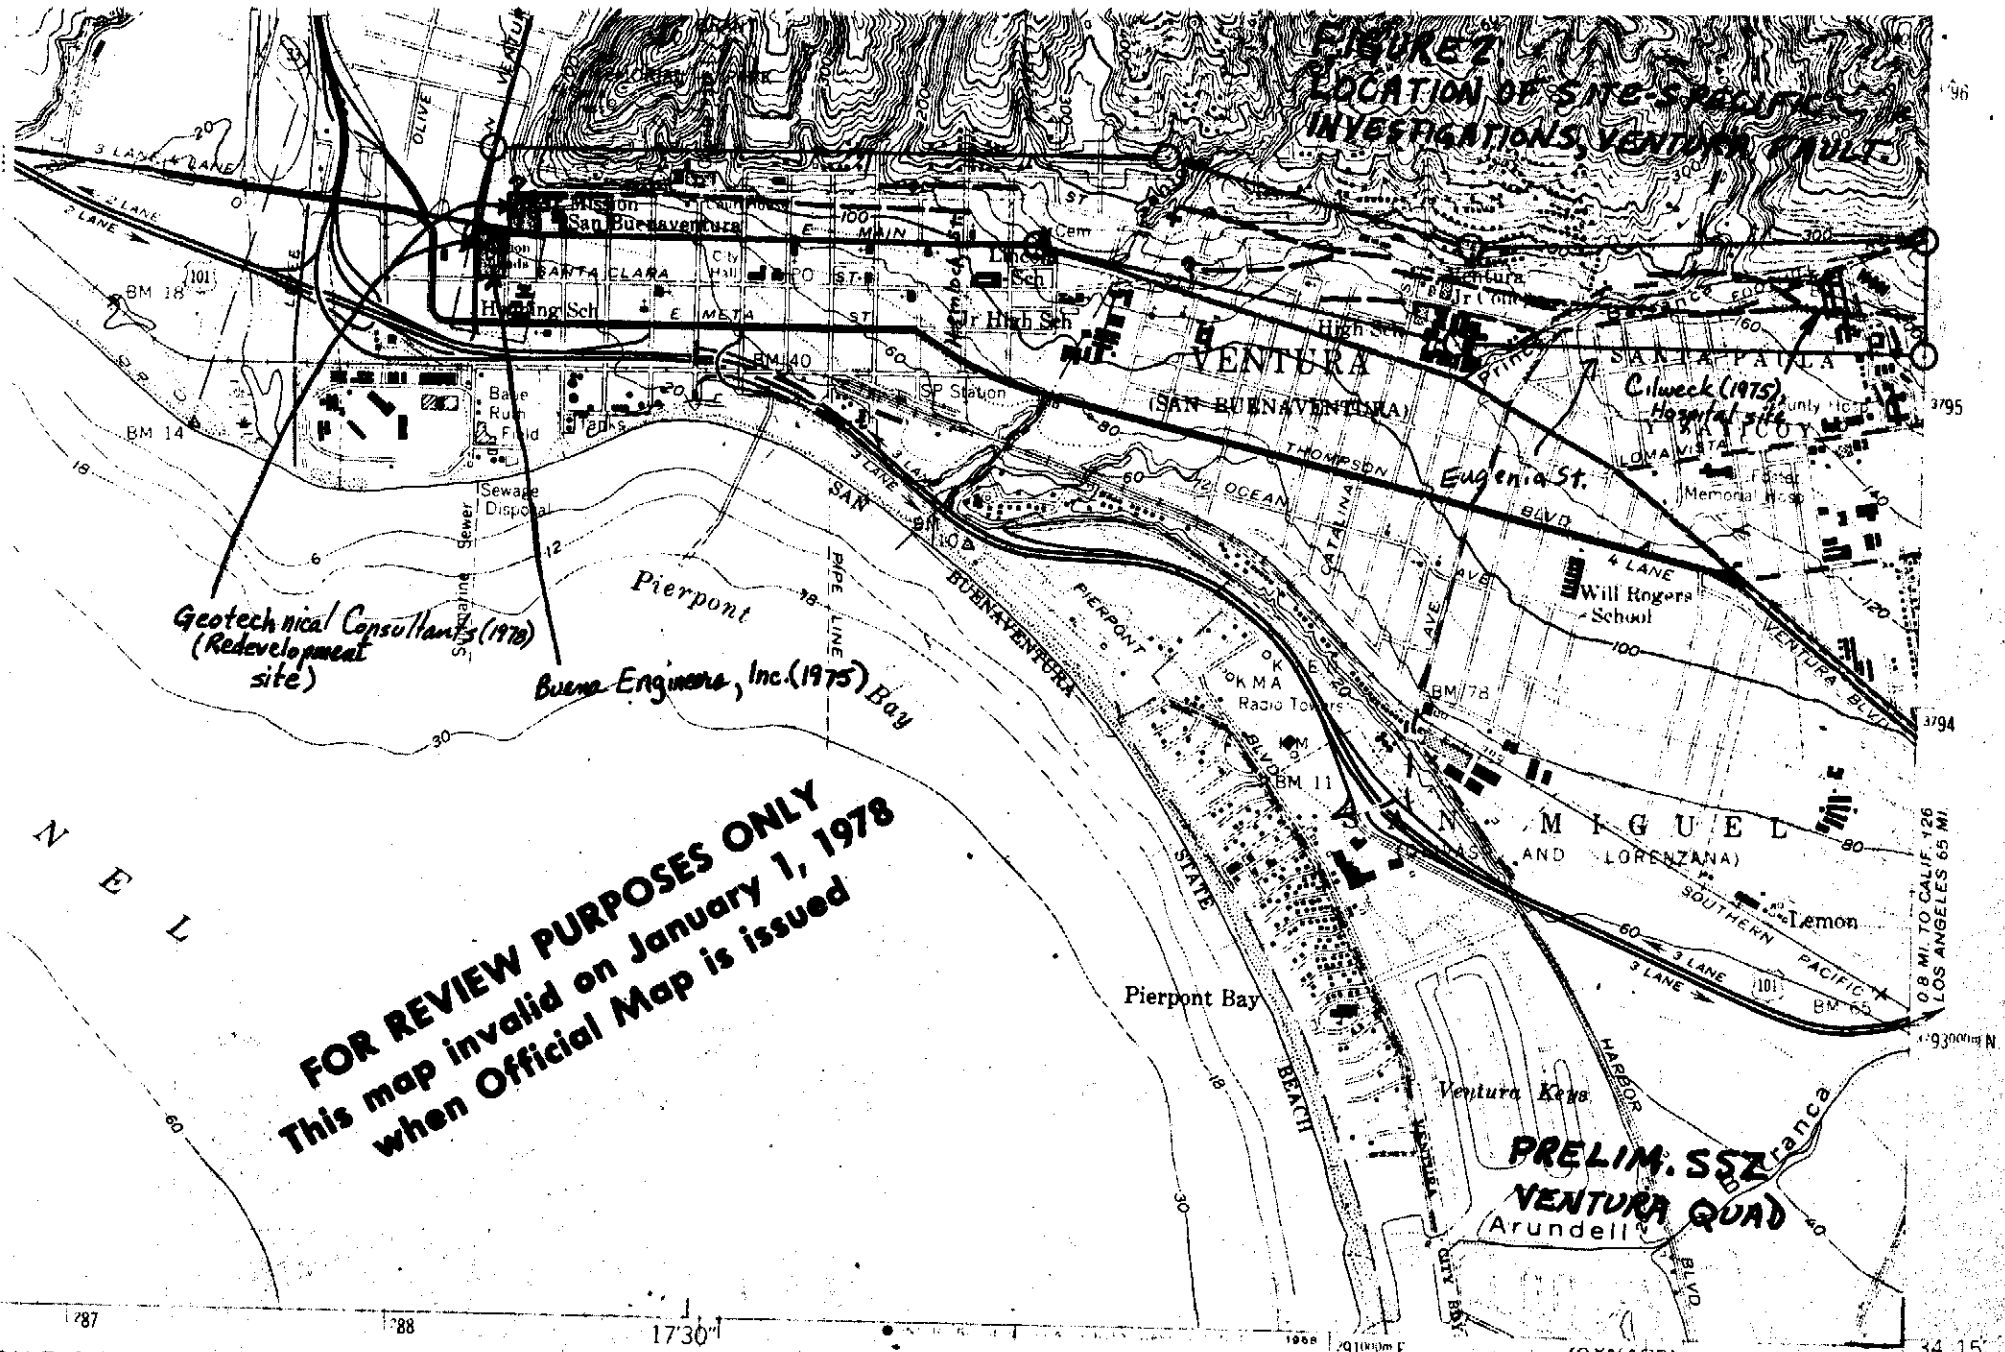
**FIGURE 2
LOCATION OF SITE-SPECIFIC
INVESTIGATIONS, VENTURA FAULT**

e. Geotechnical Consultants (1978) -- This report is based on detailed investigations of the Mission Plaza Redevelopment site at the west end of the Ventura fault (figure 2). The investigation consisted of a series of short, discontinuous trenches, 6 drill holes (partly logged visually), and 4 boreholes. The steepness of the topography and existing structures (walls, stairs, etc.), landscaping and fill prevented continuous trenching across the east-west topographic escarpment, believed by Sarna-Wojcicki, et al. (1976) to be the surface expression of the Ventura fault. Based on their observations and interpretations, Geotechnical Consultants (p. 15) believe that the escarpment origin is "unrelated to an active Ventura fault as postulated by the California Division of Mines and Geology and the U.S.G.S." They concluded that there was no hazard from surface fault rupture at the investigated site. It was their opinion (p. 16) that "the escarpment represents a semi-dip slope developed by erosional modification...coincident with the formation of the Ventura Avenue anticline." What they do not explain is 1) what erosional mechanism (e.g. wave cut face or stream bank erosion) produced the escarpment and 2) why no evidence exists for such a process at the site.

f. Buena Engineers, Inc. (1975) -- This report covers the portion of the Mission Plaza Redevelopment site south of Main Street (figure 2). It is a non-definitive study based on shallow boreholes. The report provides no correlation sections and concludes that there is no fault hazard.

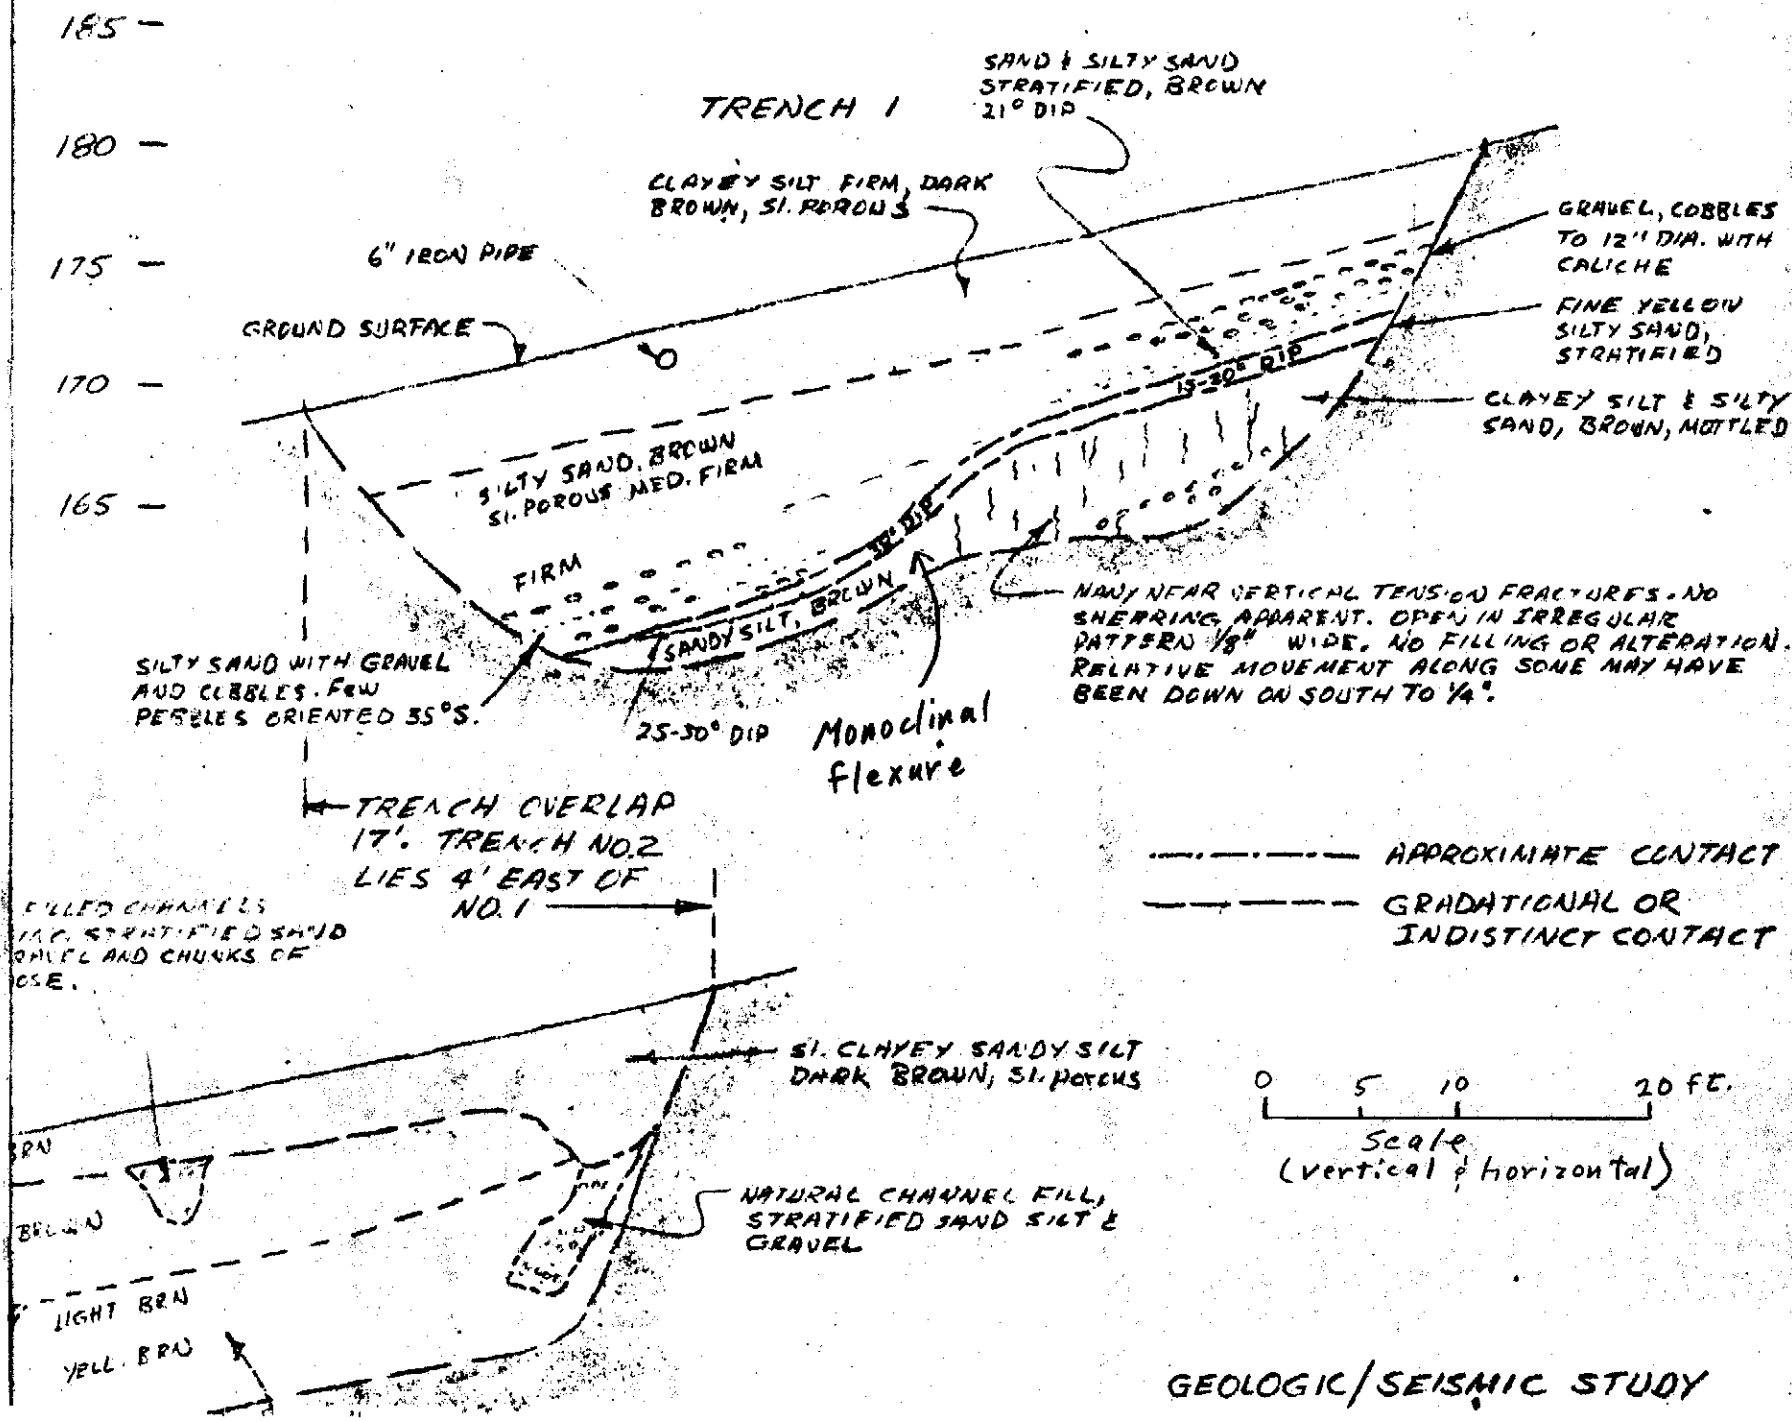
Supplement to FER-13,
Figure 3. Log of Trench 1 (copied from Cilweck, 1975, Fig. 5)

Two of the three trenches were located on or across the escarpment and both showed monoclinal flexing. Trench 1, located west of Hillmont Ave.

and near the toe of the escarpment showed a sharp, small-scale flexure

as shown on figure 3 herein. A larger, faulted monocline was also

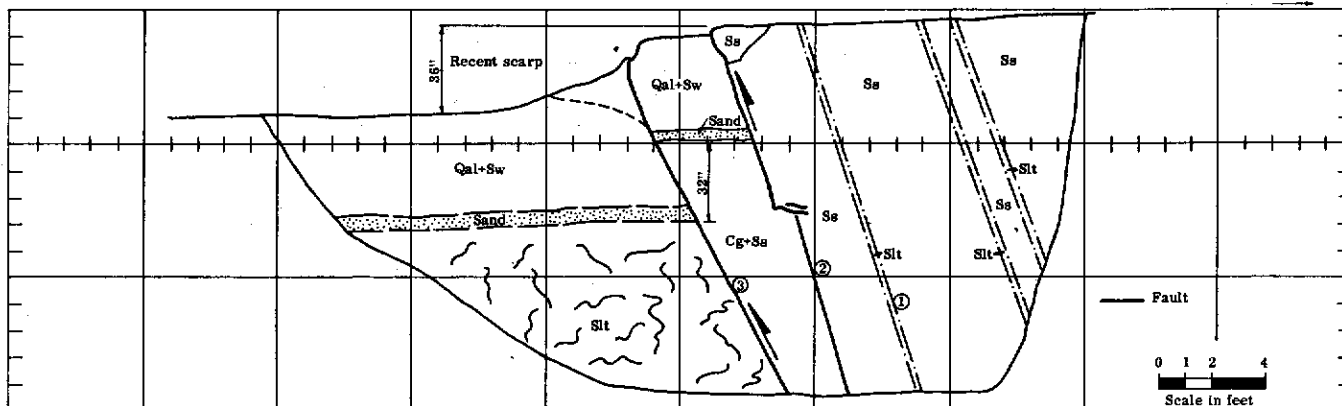
Figure 2.—Geologic pit log for Trench 1.

Logged by <u>Heath</u>		<u>Northern Trace - Lopez Canyon</u>		Tract <u>Lopez Canyon</u>	
Type of rig 24" <u>backhoe</u>		Pit location		Date <u>3-30-71</u>	
ATTITUDES		ENGINEERING GEOLOGY DESCRIPTION		PHYSICAL CONDITION	COMMENTS
① Bedding N77W, 74N	Qal & Sw,	Alluvium and slope wash, silty sand with angular clast of Silt + Ss and well rounded pebbles. Well bedded sand at base, stream deposits with some pebbles and cobbles at base.		Soft-friable	None
② Bedding plane fault N80W, 75N	Silt,	Siltstone, medium gray, iron stain-mass. -highly fractured		Firm	
③ Fault N75W, 62N	Ss + Silt,	Sandstone with thin siltstone interbeds well bedded, beds up to 4' thick.		Firm-hard	NATURAL SLOPE
	Cg + Ss,	Conglomerate and sandstone matrix - white, clean, lg. and meta. clast up to 3"		Firm-hard	None

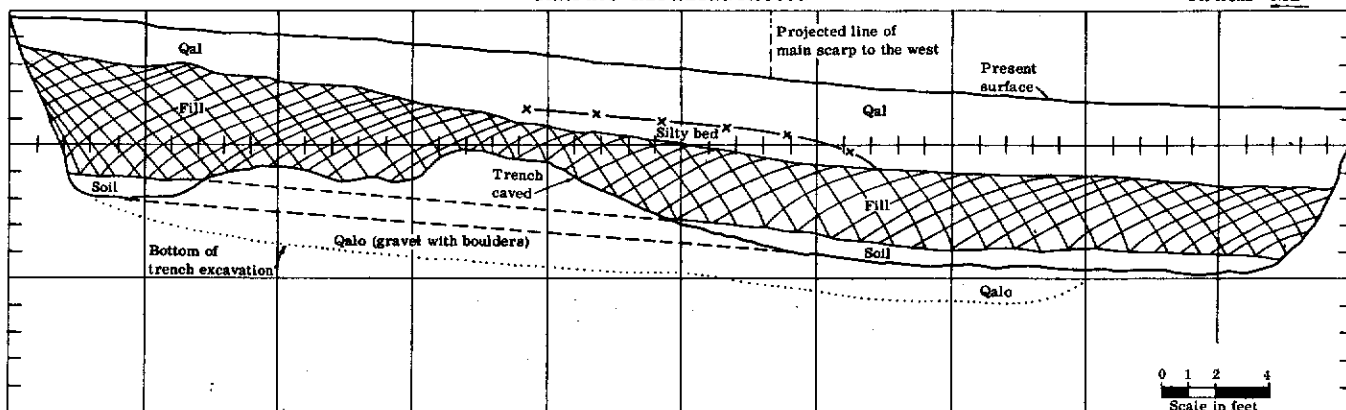
Figure 3.—Geologic pit log for Trench 2.

Logged by <u>Heath</u>		<u>85'E of trench 1, Northern Trace Lopez Canyon</u>		Tract <u>Lopez Canyon</u>		
Type of rig <u>backhoe</u>		<u>Pit location</u>		Date <u>4-12-71</u>		
ATTITUDES	ENGINEERING GEOLOGY DESCRIPTION			PHYSICAL CONDITION	COMMENTS	
None	Qal,	Alluvium, light gray sand and some gravel, deposited on fill, as late as spring floods of 1969, crudely bedded.			Soft and friable	No faulting in trench 36"-42" uplift on north side by warping only
	Fill,	Dark gray brown, mass to poorly laminated, sandy			Soft	
	Soil,	Dark brown-black, carbonaceous, buried grass and roots.			Soft	
	Qalo,	Light gray, older alluvium, gravel and boulders in sand.			Soft-firm	
					NATURAL SLOPE	
					Graded flat
